CRESTWOOD CP-201 TAPE RECORDER

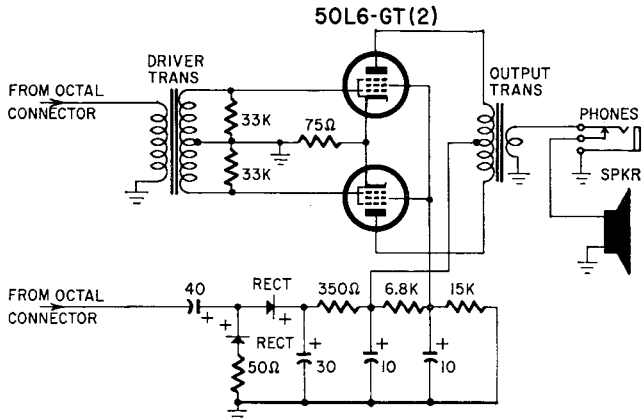
Complaint: Intermittent and noisy sound on playback. The intermittent condition was more noticeable when the recorder was played back using low volume settings, and at times the sound would become very noisy.

Cure: A scope check was made on the power amplifier chassis, and the trouble was isolated to a intermittent connection in the center tap of the driver transformer. Replacing this transformer cured the trouble.—*George P. Oberto*
