SERVICE BULLETIN NO:00007

MODELS : TX-DS989

SUBJECT : The sound of fan is large.

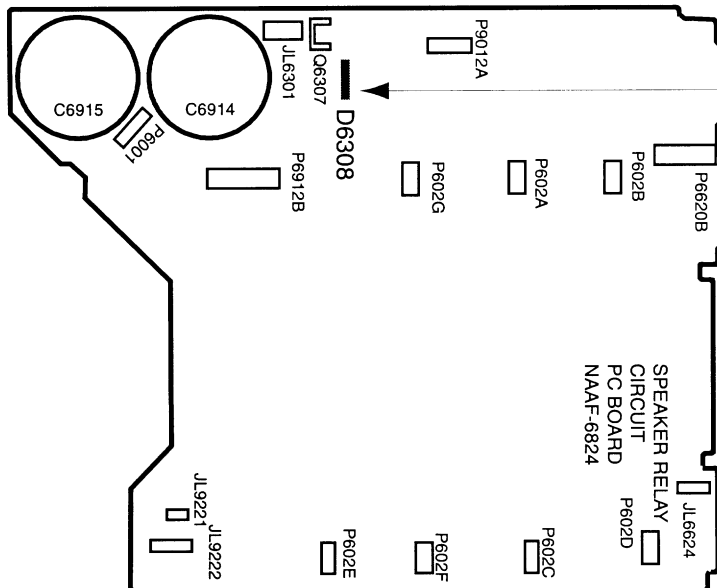
Symptom: The rotation sound of the fan is large.

Counter-measure: The drive voltage of the fan is decreased from 13V to 10V so that the operation sound when rotating is decreased.

Replace the zener diode D6308 to MTZJ10C on the PC board below.

Change the zener diode to MTZJ10C.
(Part No.224471003)
