MUSIC VISION CORRECTIONS

TELCO IN A BOX CORRECTIONS

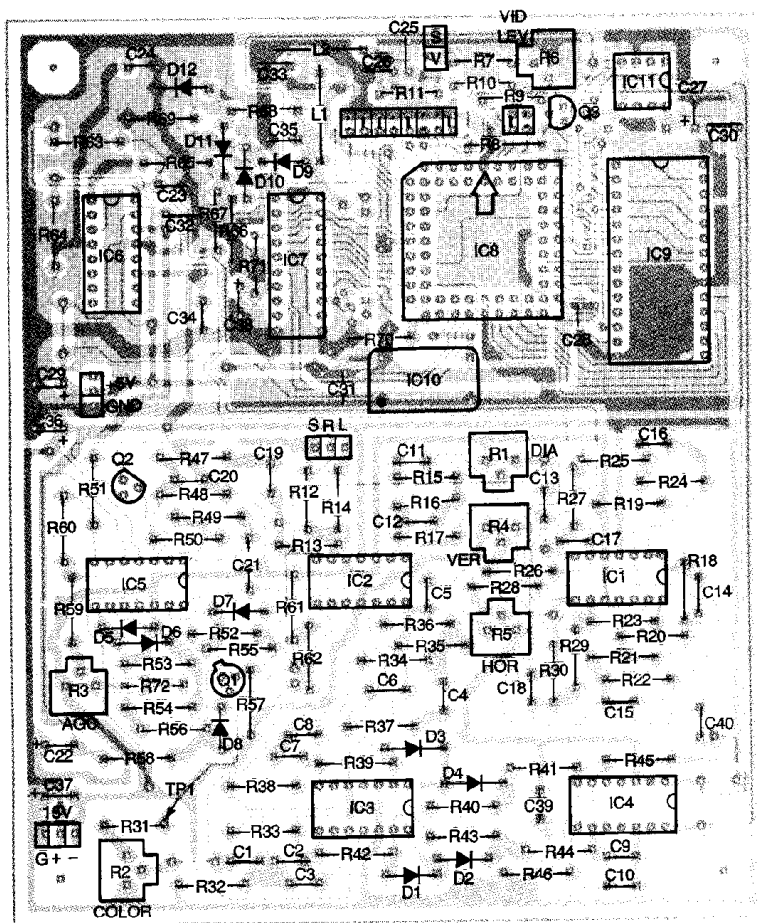
An error appeared in the parts placement diagram (Fig. 10) of the article, "Music Vision" (Electronics Now, November 1995). The label for resistor R59 was incorrectly placed; It appeared as an unlabeled jumper located below R60. In addition, the solder-side of the PC board was reversed in the X-ray view, Fig. 10. The corrected version is shown below.—Editor

CORRECTED DIAGRAM for Music Vision article.
