VCR 98-02

Hitachi Home Electronics (America), Inc.
National Service

MODELS: VT-MX221A (U71032889), VT-MX421A (U71066989),
VT-MX421AC (U71013401), VT-FX601A (U71005401),
VT-MX424A (U71018989)

SUBJECT: INSTALLATION OF KIT, PART NUMBER X480195

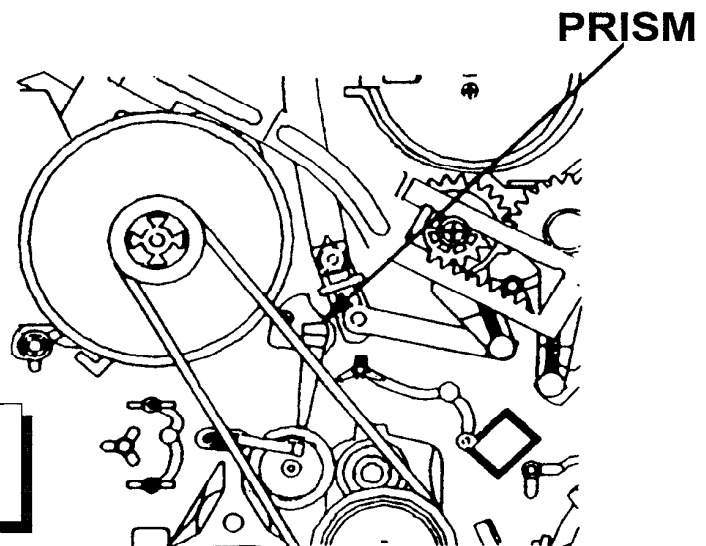
Figure 1

SYMPTOM: Within 15 seconds, unit shuts-OFF & Indicator indicates
ERROR CODE #1

- 1.) Replace the Prism (Shown in Fig. 1) on the Deck Mechanism with the new one.
- 2.) Replace D511 with new one.

CAUTION: Please pay attention to the following when replacing D511.

- a) Do NOT apply any mechanical stress to the leads.
- b) Solder in D511 quickly, do NOT apply excessive heat.
